Operation of a Removable Barrier on Morpion Stream - 2015

US Fish and Wildlife Service

Lake Champlain Fish and Wildlife Resources Office

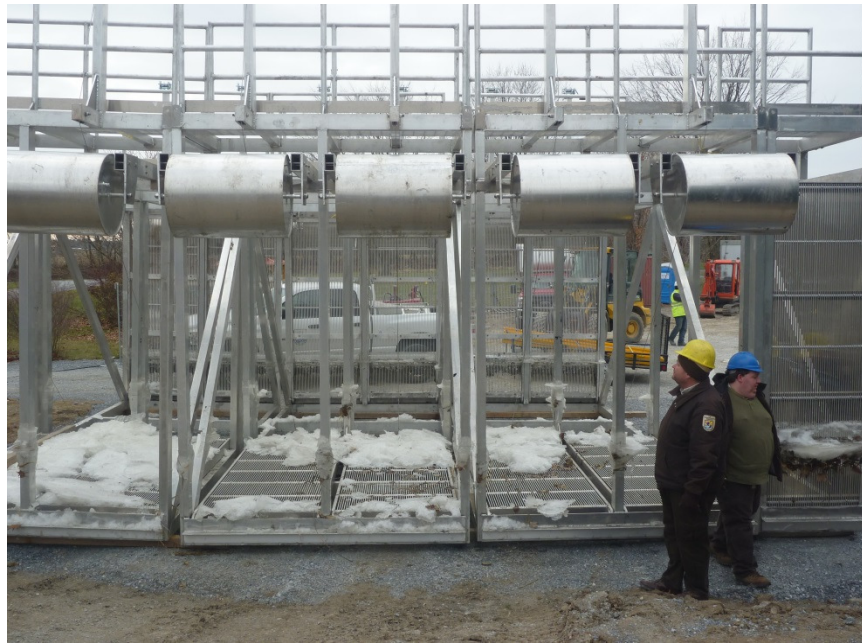
Figure 1. A picture of the barrel floats on the Morpion sea lamprey barrier. The modules are shown here during storage, and are shown with the grates in the down position, as they would be if the barrels were to float during a high water event and allow the grates to fall to the streambed.

One of the most important and innovative features of the Morpion barrier is its ability to be easily installed in the spring, prior to adult lamprey retuning to spawn, and removed from the stream after the spawning season. This allows the stream to remain free-flowing for nearly 10 months during the year. The barrier consists of a walkway above a series of screen panels or “grates” that are placed side by side and raised from the stream bed forming the face of the barrier. Each individual grate has an attached float barrel mechanism (Figure 1.) so that if the water rises high enough for the barrel to float, it will automatically trip, allowing the grate to be released and fall down to the stream bed. This feature allows the water and any debris that has accumulated to pass downstream. The barrier has 12 vertical grates that are placed at a 60 degree angle to stream flow to increase the surface area of the barrier while also directing fish that encounter the barrier while moving upstream into a trap.

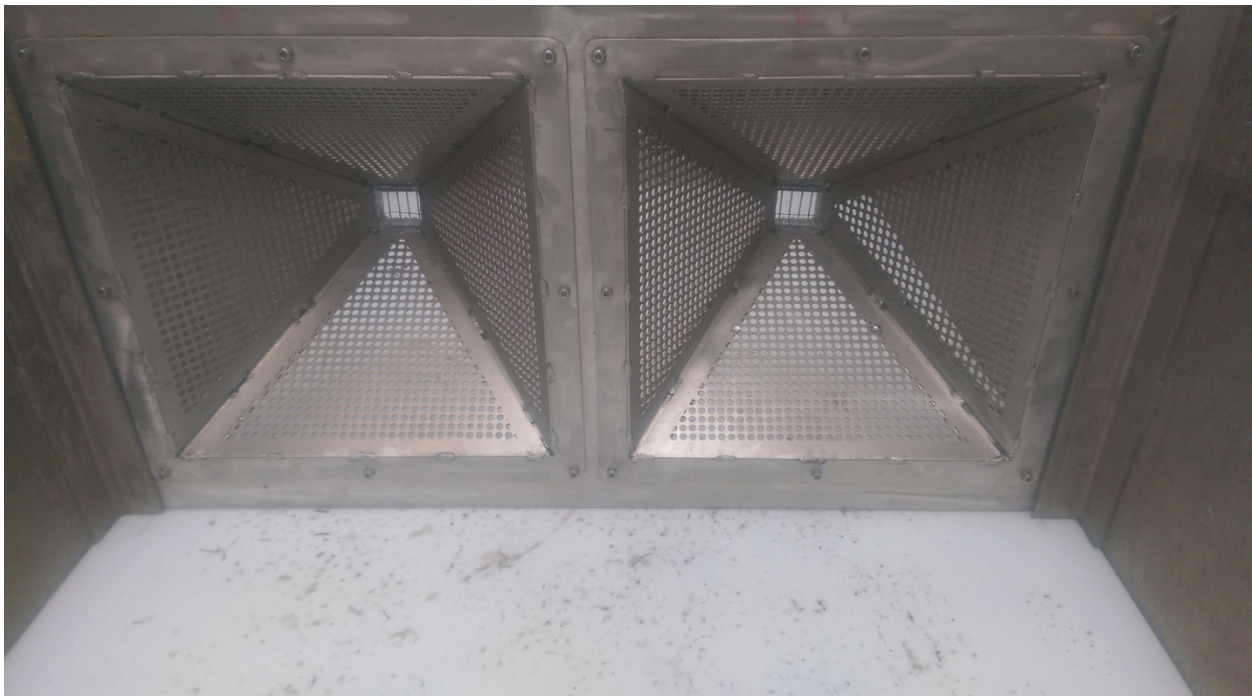
Figure 2. A picture of the funnels that separate the first and second stages of the fish and lamprey trap on Morpion Stream. In addition to the two funnels shown in this picture, two additional funnels are stacked on top.

The trap is a two-stage trap with larger fish being collected in the first stage and smaller fish and lamprey being collected in the second stage. To enter the first stage of the trap, also known as the “V – Trap”, fish must pass through the V notch. This V notch consists of two bar racks oriented vertically, and can be adjusted to allow larger fish to enter, or closed to allow only smaller sized fish to enter. The second stage of the trap is where the lamprey and smaller fish are collected. To pass from the V – Trap into the second stage trap, fish must make their way through one of four funnels. The narrow end of the funnels have a 2.5 inch (64mm) square opening (Figure 2.). This two-stage trap is designed to facilitate the passage of fish that encounter the trap, while also allowing easier processing by separating out lamprey and smaller fish into the second stage of the trap.

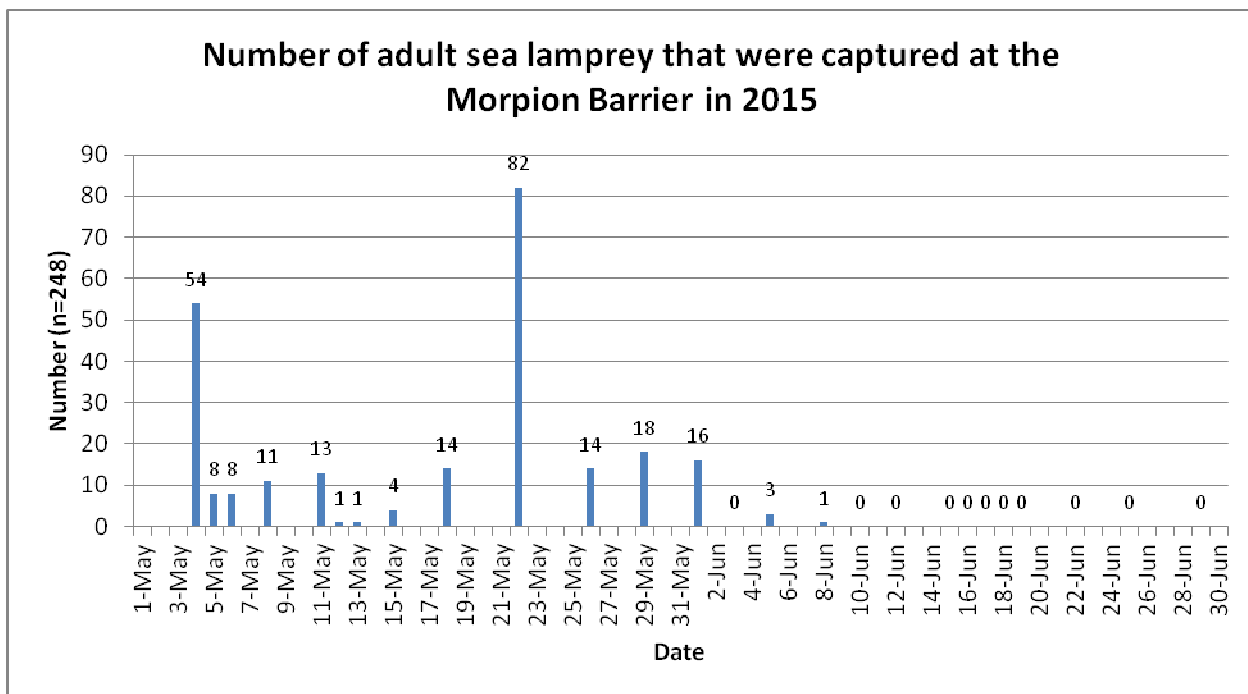
Figure 3. Date and number of adult sea lamprey captured at the Morpion barrier in the spring of 2015.

The first adult lamprey (54) were captured on May 4th (Figure 3.), the first date that the trap was checked in 2015. This compares to the first adult captured on May 9th in 2014. The last adult sea lamprey was captured on June 8th. That compares to June 13th in 2014. For the season we captured 248 adult sea lamprey, compared to 134 in 2014. Most of the adult sea lamprey captured in 2015 were held in a live cage and transferred to the University of Montreal for research.

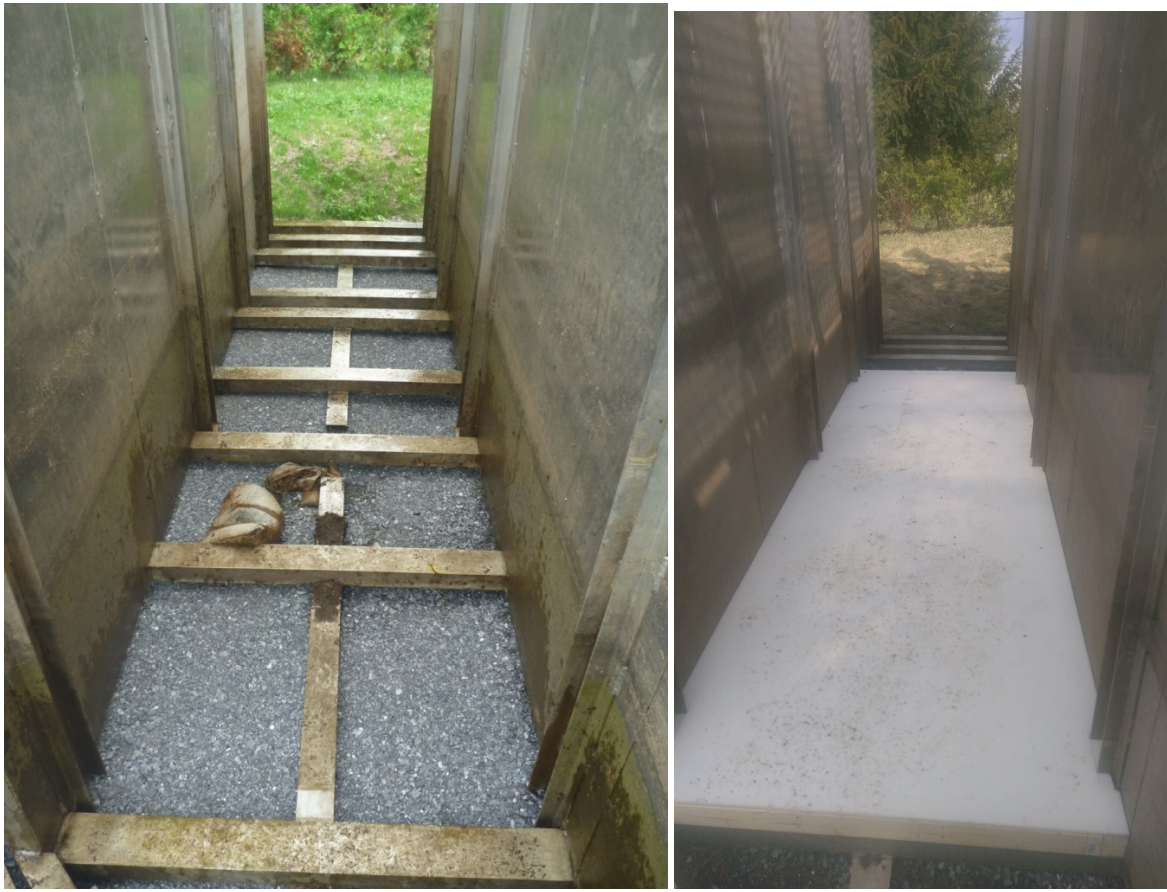
Figure 4. A view of the bottom of the two stage trap on Morpion Stream (in these pictures the diving wall and funnels that separate the first and second stages of the trap have been removed). The picture on the left shows the bottom of the trap during the 2014 season. The picture on the right shows the new floor that was installed prior to the 2015 trapping season to prevent lamprey and non-target fish from escaping, and to facilitate easier removal when checking the trap.

During the 2014 trapping season, we were successful at removing 134 adult sea lamprey before they had an opportunity to spawn, but we had reason to believe that many more were able to make it above the barrier that year. The floor of the two stage trap did not have a solid bottom, but sat on the concrete apron installed in the bottom of the streambed. While we thought that the trap would sit flush on the concrete pad and create a good seal, we later found that this was not the case. Late during the 2014 trapping season, once water levels had dropped enough that we were able to fully inspect the trap, we found that there was a gap wide enough that most lamprey could squeeze through and continue upstream. During the 2014 trapping season we also collected three adult sea lamprey that were pinned to the upstream side of the grates, possibly washed there after they died following spawning. We were also able to confirm that spawning had occurred above the barrier in 2014 by finding young of year lamprey at 3 of 6 access sites surveyed that summer during our electro-fishing larval survey. While some adults may have passed when screens were down during high flow events, it is also likely that many were able to pass through the trap and continue upstream while we thought we had the stream blocked off.

Prior to the 2015 trapping season we installed a floor in the bottom of the two stage trap. We installed a white high-density polyethylene floor in the bottom of both the first and second stage of the trap to prevent fish and lamprey from escaping through the channel in the bottom of the trap. We believe the new floor was very successful at preventing both fish and lamprey from escaping and was evident in the large increase in both the number of lamprey and non-target fish we collected in the trap this year. The white floor was also helpful for seeing into the trap making it easier to net and remove both lamprey and non-targets. The floor was also great at providing a flat surface for netting and removing both sea lamprey and non-targets.

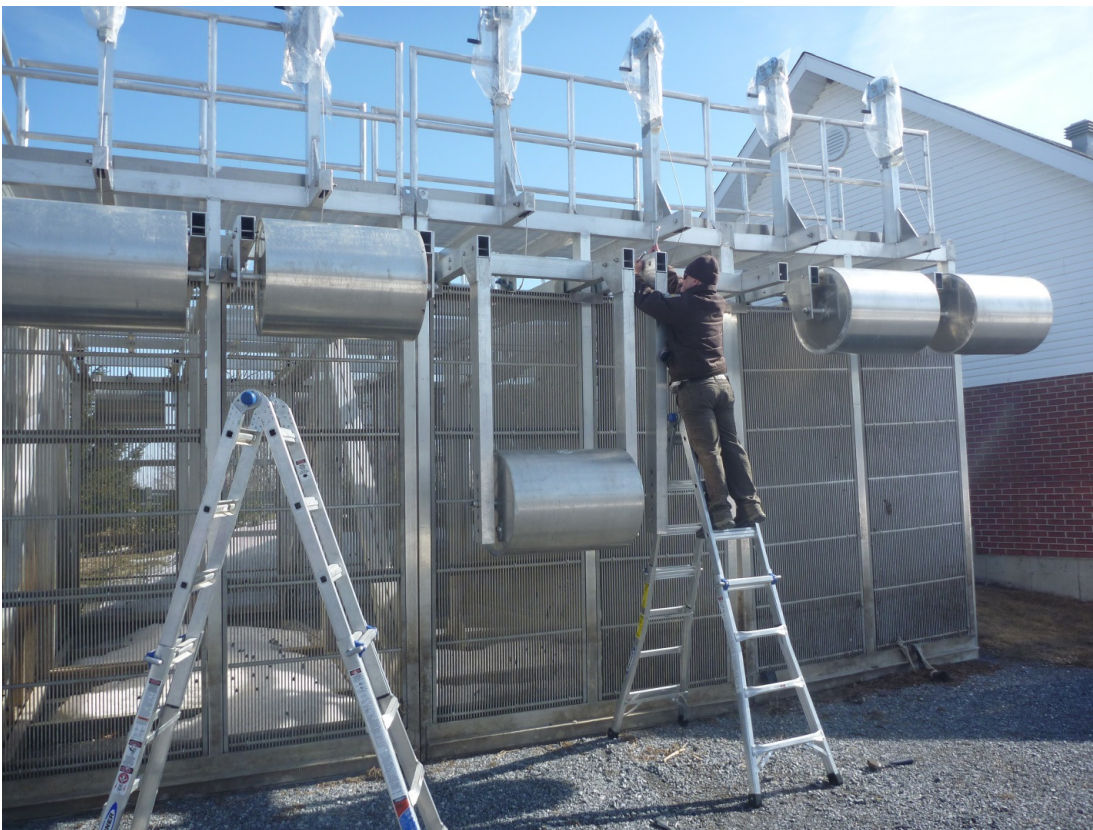
Figure 5. – New barrel extensions were added prior to the 2015 trapping season to lower the elevation of the barrels approximately 3 feet (1 meter) to allow the grates to drop before the water reached bankfull height.

During the spring 2014 trapping season, we found that the bank elevation on the west bank of the barrier was lower than the elevation that the water would need to reach in order to raise the barrels, thereby allowing the grates to trip and lower. This was an error in construction that prevented the barrier from operating as designed. To address this problem, either a berm (raise the bank elevation) could be built or the height of the barrels could be lowered. A decision was made to lower the barrels rather than alter the river bank. To do this, we added new extension brackets that allow the barrels to extend further downward, approximately 1 meter, such that they will trip while the water level is below bankfull. Kleinschmidt Associates, the engineers who designed the barrier, drafted the new engineering plans for the float modifications. This will prevent the barrier from backing up water and flooding the adjacent field in the future. Due to the time required to draft engineering plans, secure funding, obtain materials, and fabricate the modifications we were not able to make the modifications during the 2014 trapping season. Prior to the start of the 2015 trapping season, barrel extensions were added to lower the barrels (Figure 5. and 6.).

During the 2015 trapping season, we had a number of high water events in June, and the barrels functioned as designed by tripping and allowing the grates to drop to the streambed before the water elevation reaches bankfull and spills into the neighboring field. During a flood event on June 9th the Pike River (no gage available on Morpion stream) rose from 15cms to over 120cms. Water from the Pike flooded its banks, and a portion of the park near the mouth of Morpion stream was flooded. During this flood event all 12 barrels tripped and the grates were lowered to the stream bed as designed.

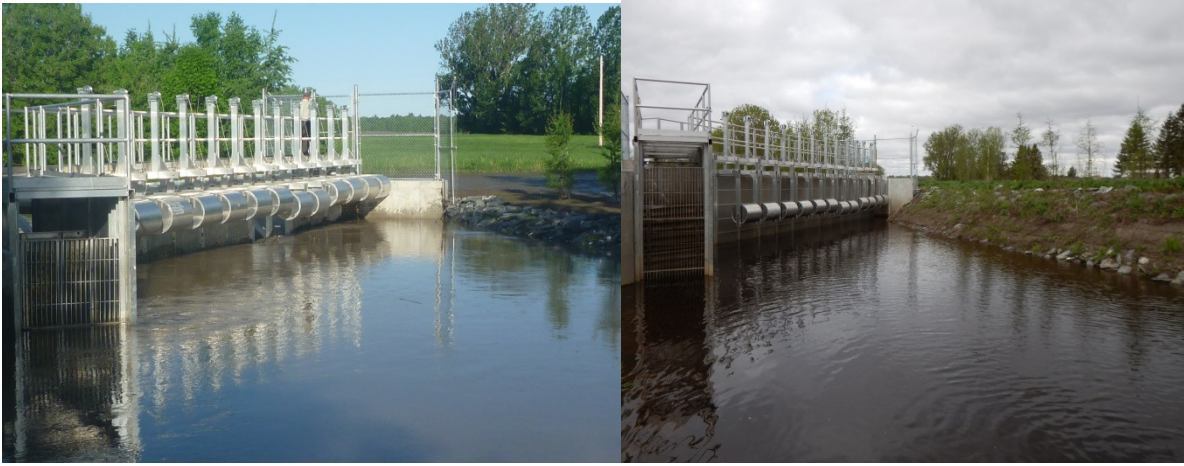
Figure 6. – Height of the float barrels during the 2014 season (on the left). Height of the barrels after installing the barrel extensions to lower the barrels prior to the 2015 trapping season (on the right).

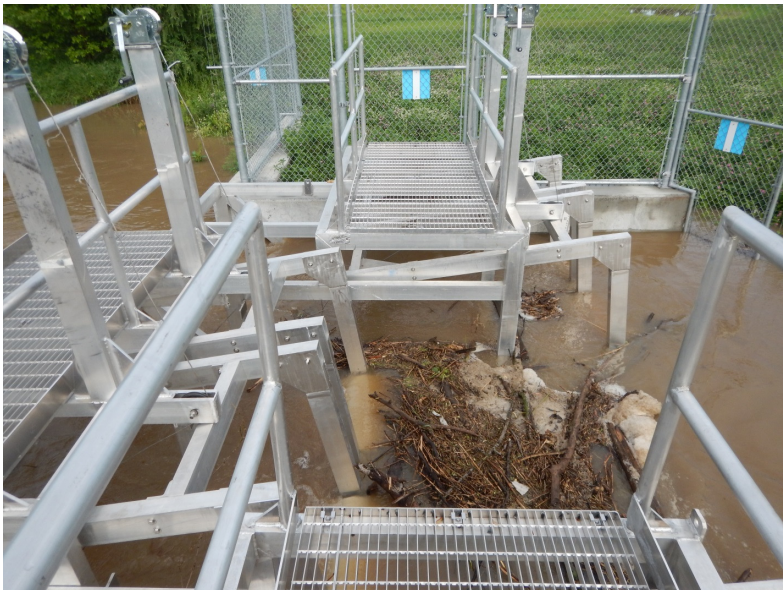
Figure 7. – In this picture module #2 (second from the river right) of the Morpion barrier had been pushed back approximately 6 feet (2 meters) during a high water event in early June of 2015.

The barrier is made up of 6 modules, each having 2 grates and corresponding barrel floats. These 6 modules line up flush with each other and form the wall of the barrier. Each module is held in place by a steel rail in the concrete apron at the upstream end, and by a C channel groove that the module sits in on the downstream side. The downstream C channel is approximately 4 inches (100mm) deep. During the installation in the spring of 2015 we noticed that some of the modules were sitting up a little higher on the downstream end, likely because sand or debris was in the C channel. We thought that if the modules were sitting in the channel 2 – 3 inches (50mm – 75mm), that it would be enough to prevent downstream movement of the modules. While the modules stayed in place under low to moderate flows, this was not the case during high flow events (Figure 7.). Four times during the beginning of June we experienced rain and high flows that pushed one or more of the modules downstream on the concrete apron. Each time, when flows receded we would manually move the modules back into place, but could never get the modules to sit completely into the C channel. In the future we now know that the C channel needs to be completely cleaned out to prevent any downstream movement of the modules.

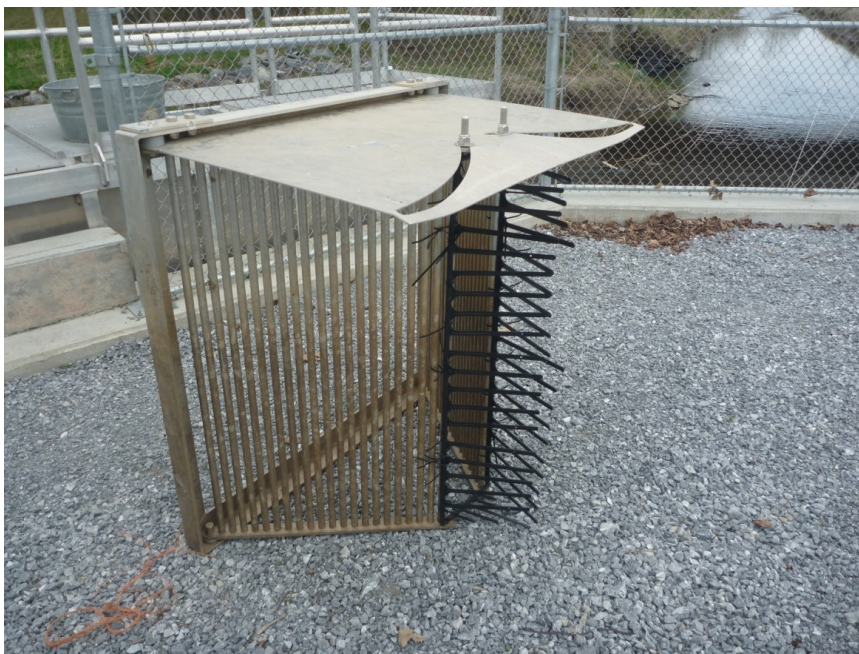
Figure 8.- The V-trap with trigger entrances (in black) attached to retain larger fish that enter the first stage of the trap were added prior to the 2015 trapping season.

The first stage of the trap, or the V-Trap section, is designed to capture and retain larger fish looking to migrate upstream, while smaller fish and lamprey are able to pass through the four cones and into the second stage of the trap. During the 2014 season, we adjusted the bar racks in the entrance to the V-Trap to a width of 254 - 305mm. For the entire season, we captured only two Snapping Turtles and one White Sucker that had become stuck in the corner of the V-Trap. Prior to the 2015 we installed trigger entrances that create a one-way entrance (Figure 8). By installing the trigger entrances, we hoped to better facilitate upstream passage of larger fish and other non-target species that encounter the barrier by ensuring they stayed in the V Trap once they entered. During the 2015 trapping season, we captured only 7 non-targets in the first stage of the two stage trap including one large snapping turtle. We found that if something large entered through the V-trap the trigger fingers would often push open and remain open allowing fish or other non-target species to exit. We hope to find a better way to attach the trigger entrance to the V-trap so that they will spring back and prevent non-targets from exiting through the V-trap entrance.
